## **HISTORIC PRESERVATION COMMISSION MEETING AGENDA**

## **HISTORIC PRESERVATION COMMISSION MEETING MINUTES**

National Park Service  
U.S. Department of the Interior  
Technical Preservation Services

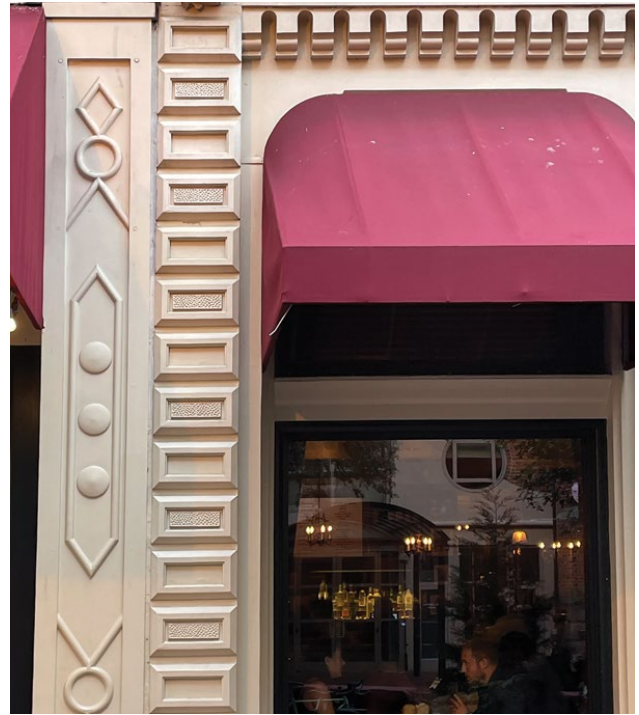
*Figure 2b: The 19th century also produced a variety of metal products used to imitate other materials. Across the country, cast iron was used in storefronts to imitate stone. Photo: John Sandor, NPS.*

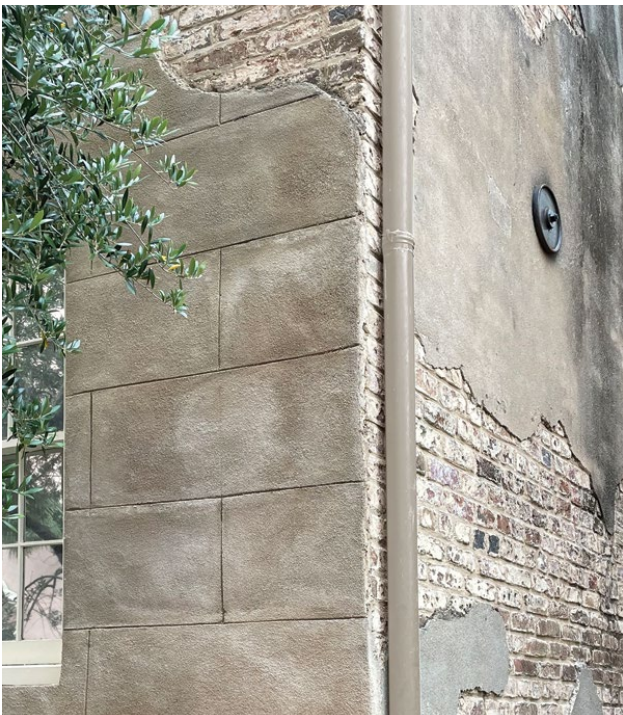
*Figure 2c: Stucco has been used to imitate a number of building materials for many centuries. Seen here, stucco was applied to a brick structure and scored to represent a stone façade. Photo: John Sandor, NPS.*

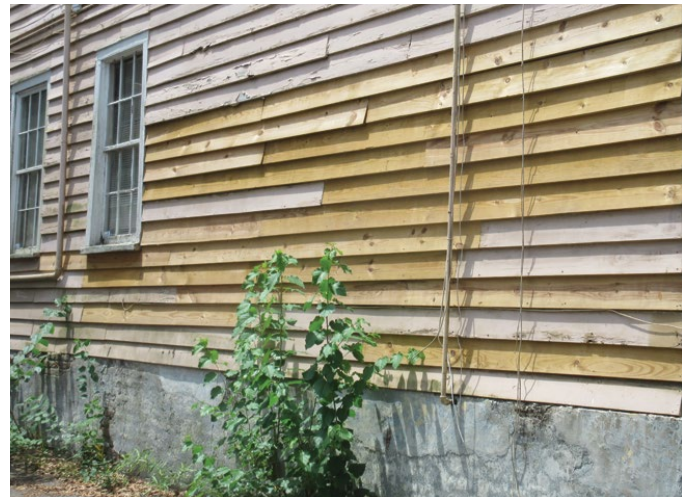
Figure 3: Incremental repair is best done using in-kind material to minimize differences in the performance characteristics that could negatively affect the overall assembly. Photo: NPS.

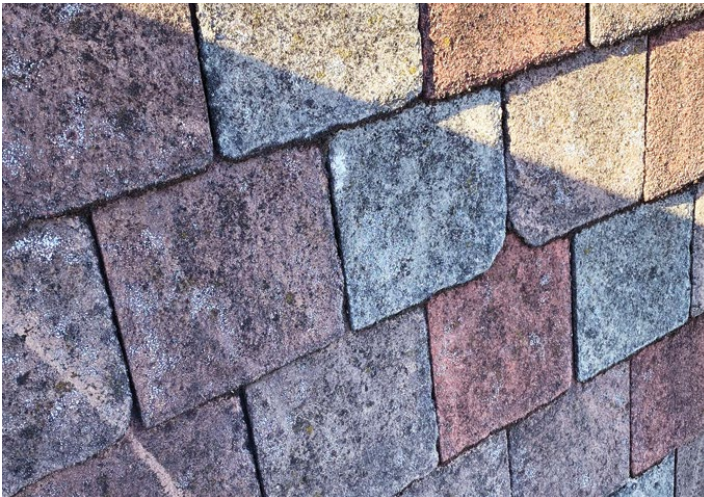
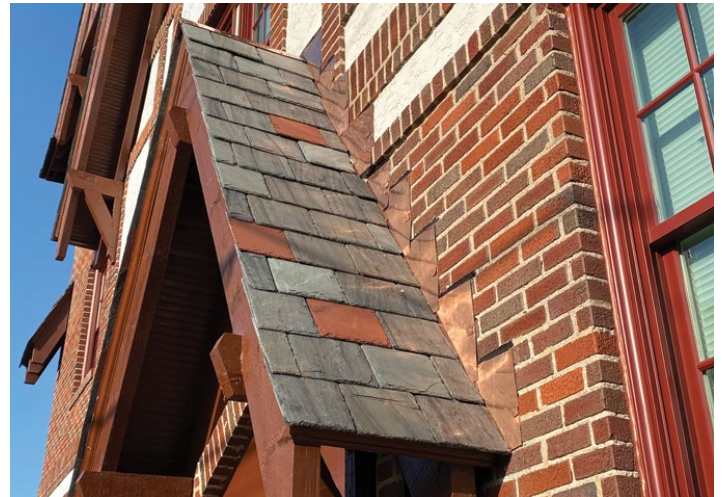
Figure 5. (Left) Asbestos shingles were often used as a substitute for traditional slate roof shingles. The historic asbestos roof on this rehabilitation project had reached the end of its lifespan and required complete replacement. (Right) Given the limited replacement materials available to match the historic asbestos shingles, utilizing natural slate was determined to be the best visual match for the original shingles and design intent in this instance. Photos: Crosskey Architects.

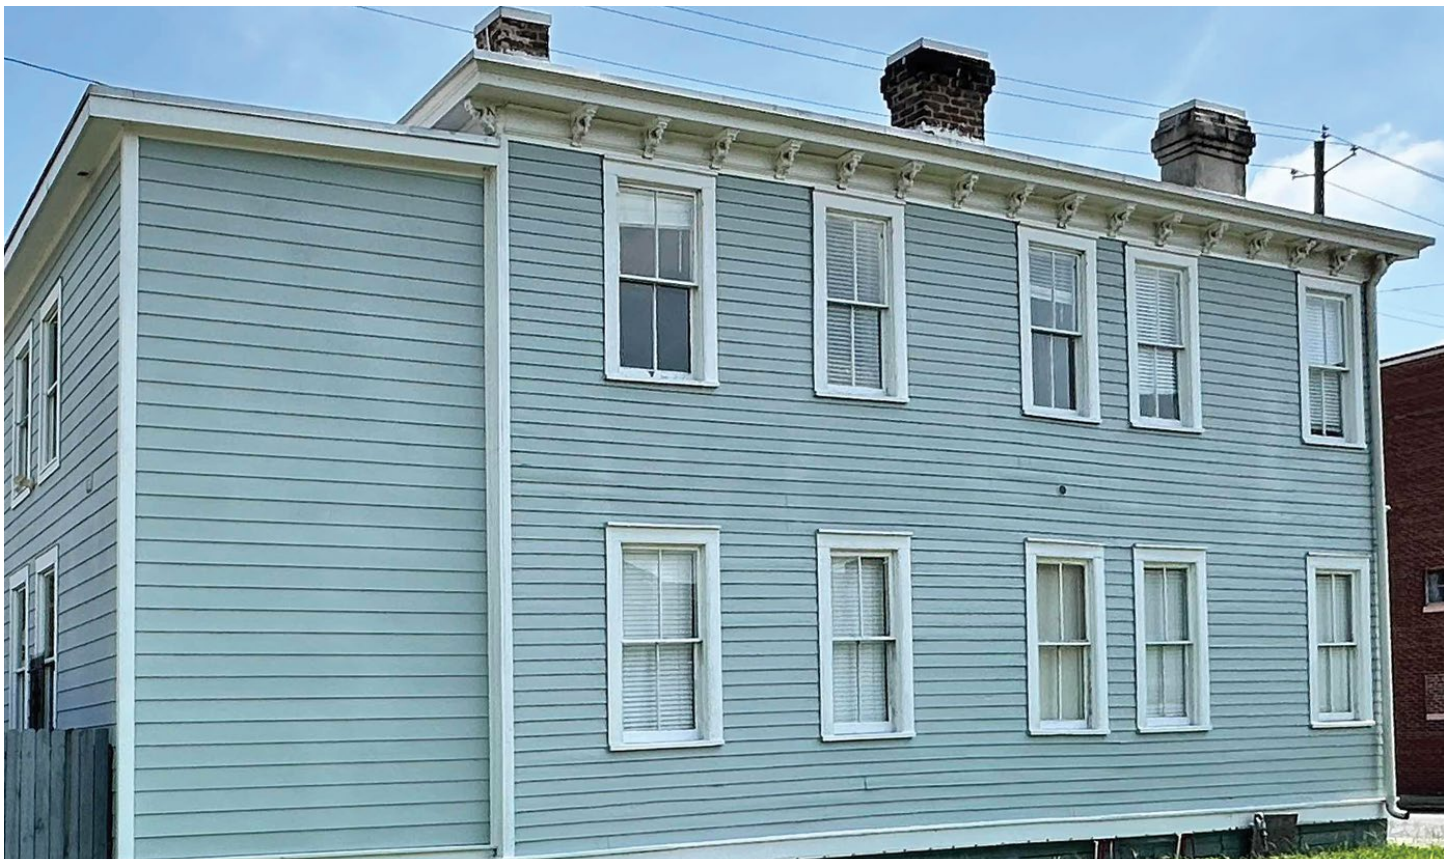
*Figure 7. A new addition replaced non-historic construction on the rear elevation of this building. Fiber cement gives the addition a compatible appearance without replicating the exposure for thickness of the historic siding. Photo: Ward Architecture + Preservation.*

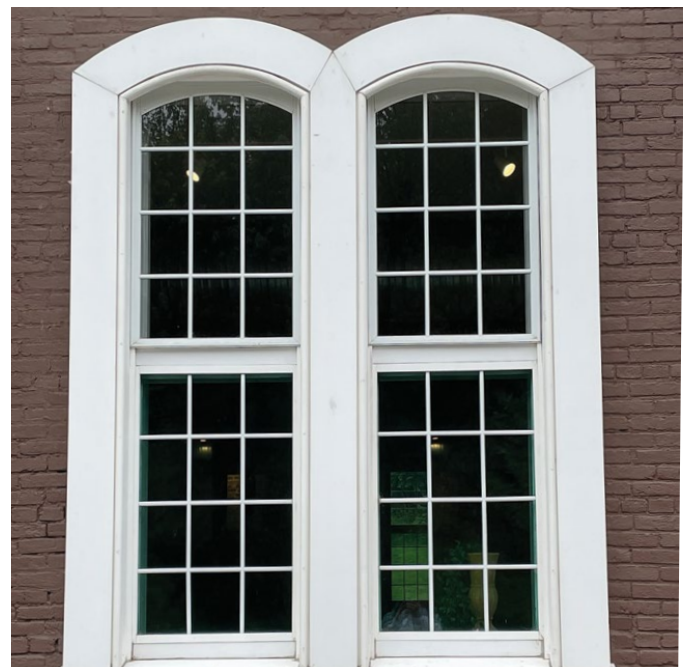
*Figure 9. Previously bricked-in openings below the flood line were reopened and new aluminum windows installed with cellular PVC trim detailed to hold back moderate flood waters and survive exposure to water. Photo: John Sandor, NPS.*

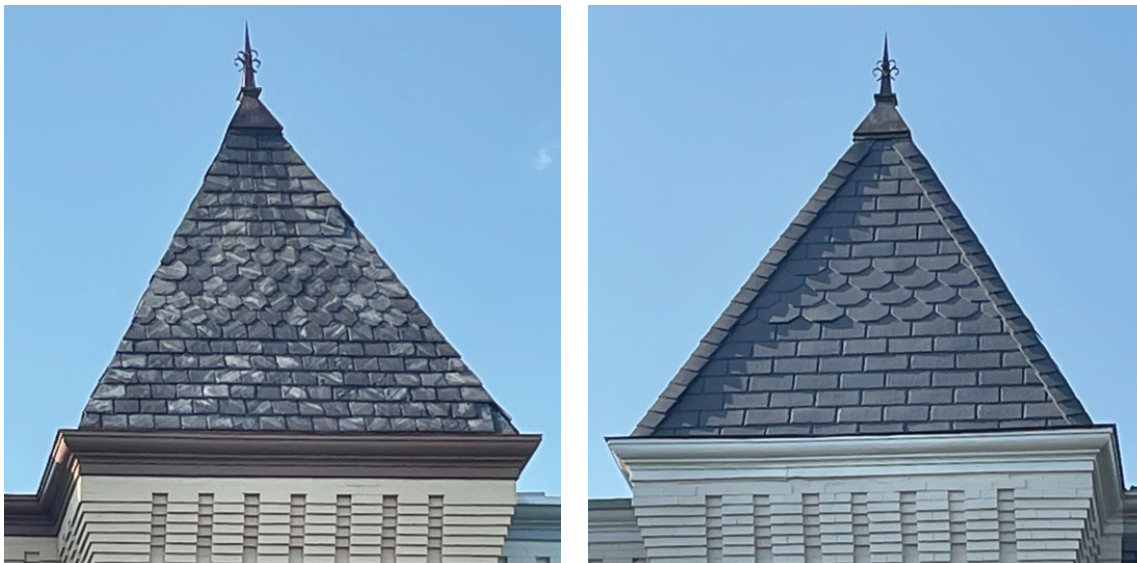
*Figure 10. Polymer slates offer a choice of shapes but not sizes, limiting their ability to achieve a good visual match for some historic slate. With the size of the polymer slates (right) being nearly twice that of the historic slates (left), the scale of the entire feature is incompatibly altered. The molded edges of this material, which contribute to its ability to replicate slate, would be lost if each shingle was resized by cutting. Photo: John Sandor, NPS.*

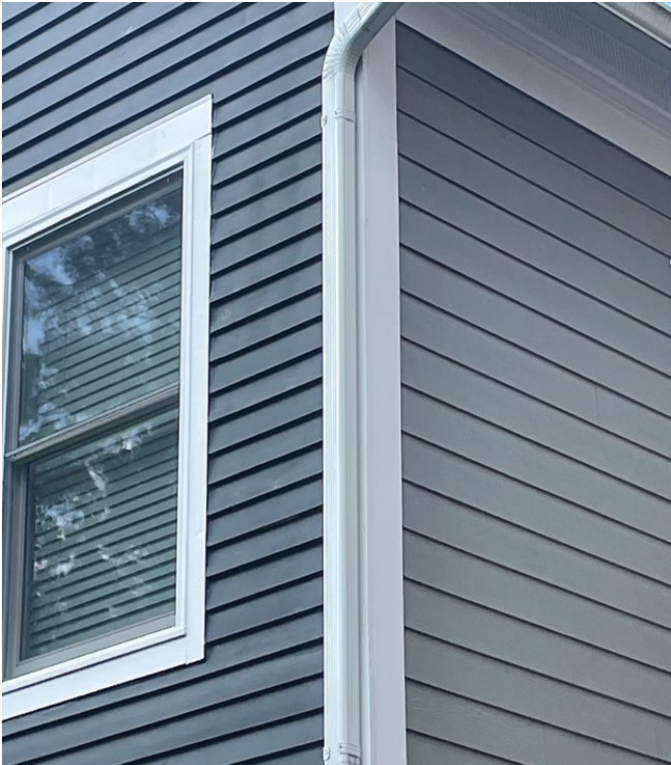
Figure 11. The thickness of the wood siding on the front (left) creates a deeper shadow line than is achieved with the fiber cement siding used on the side (right) elevation. While the exposure can be adjusted, fiber cement siding is not available in a matching thickness. Photo: John Sandor, NPS.

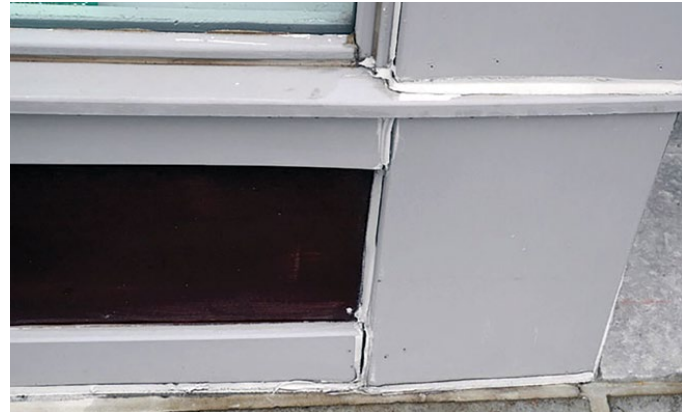
Figure 12. Cellulose composite materials, like wood, expand and contract with moisture. Here it was used to reconstruct a missing storefront. Unlike solid wood that is dimensionally stable parallel to the grain, this composite moves equally in all dimensions, resulting in gaps that were not adequately anticipated in the design. Photo: John Sandor, NPS.

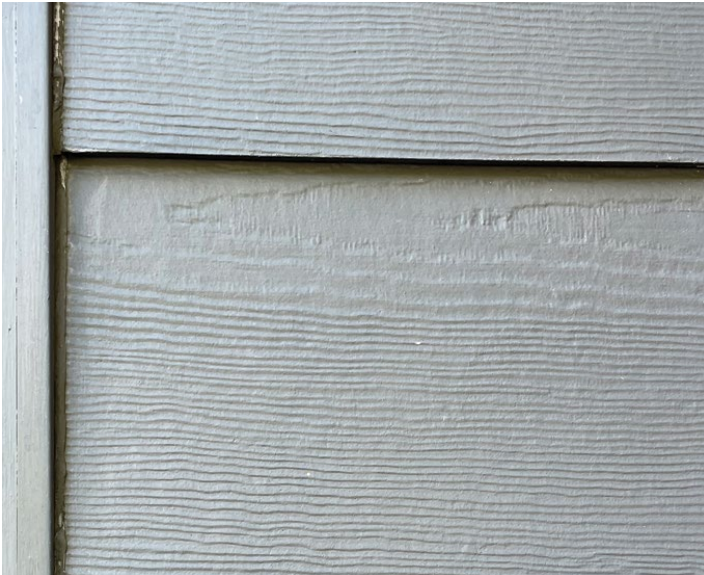
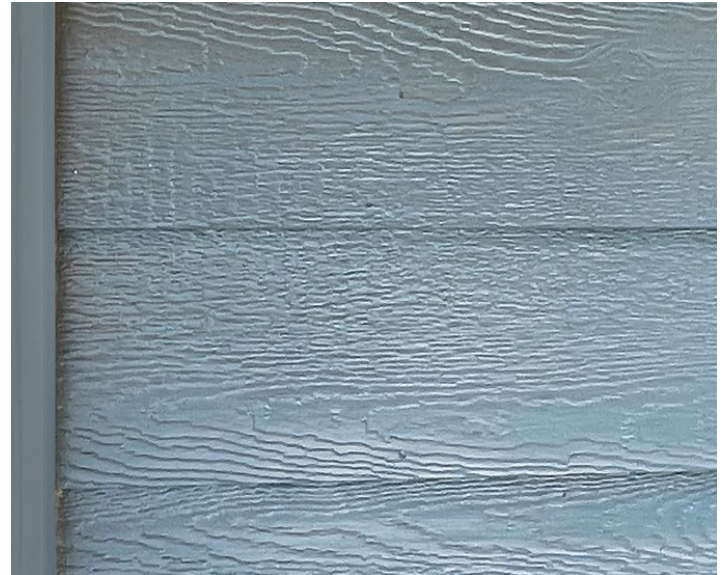
Figure 14. Surface texture is an important aspect in matching the appearance of a historic material, especially when a material is viewed at close range. As seen in these two images, many of the substitute materials produced for siding and trim have an embossed wood grain, making them incompatible for replacing historic wood that was typically planed to a smooth surface. Some substitute products are available with a smooth surface as well. Photos: John Sandor, NPS.

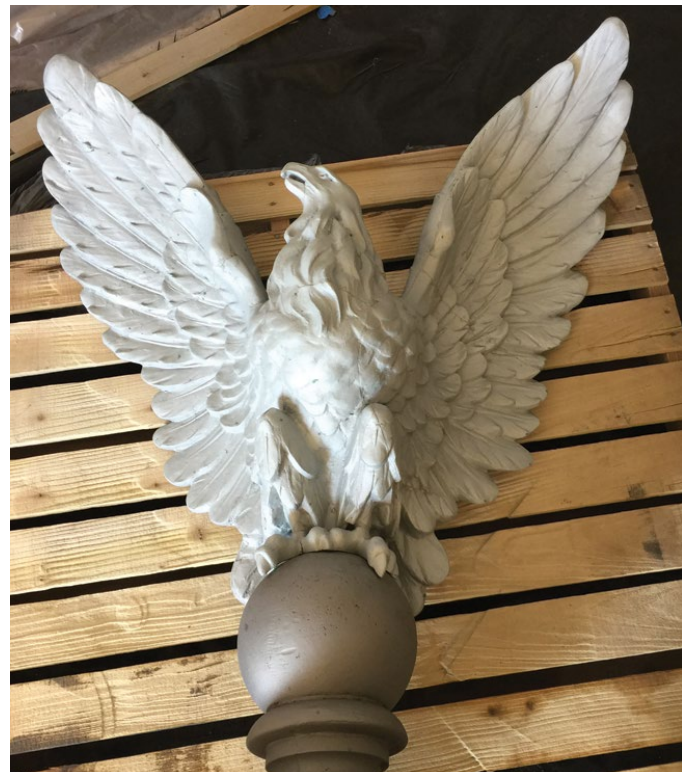
*Figure 16. Aluminum is a highly corrosion-resistant metal that is commonly used as a substitute material for cast iron. Aluminum can be a more affordable and lightweight alternative to cast iron that retains a similar texture, shape, and maintenance cycle. Photo: NPS.*

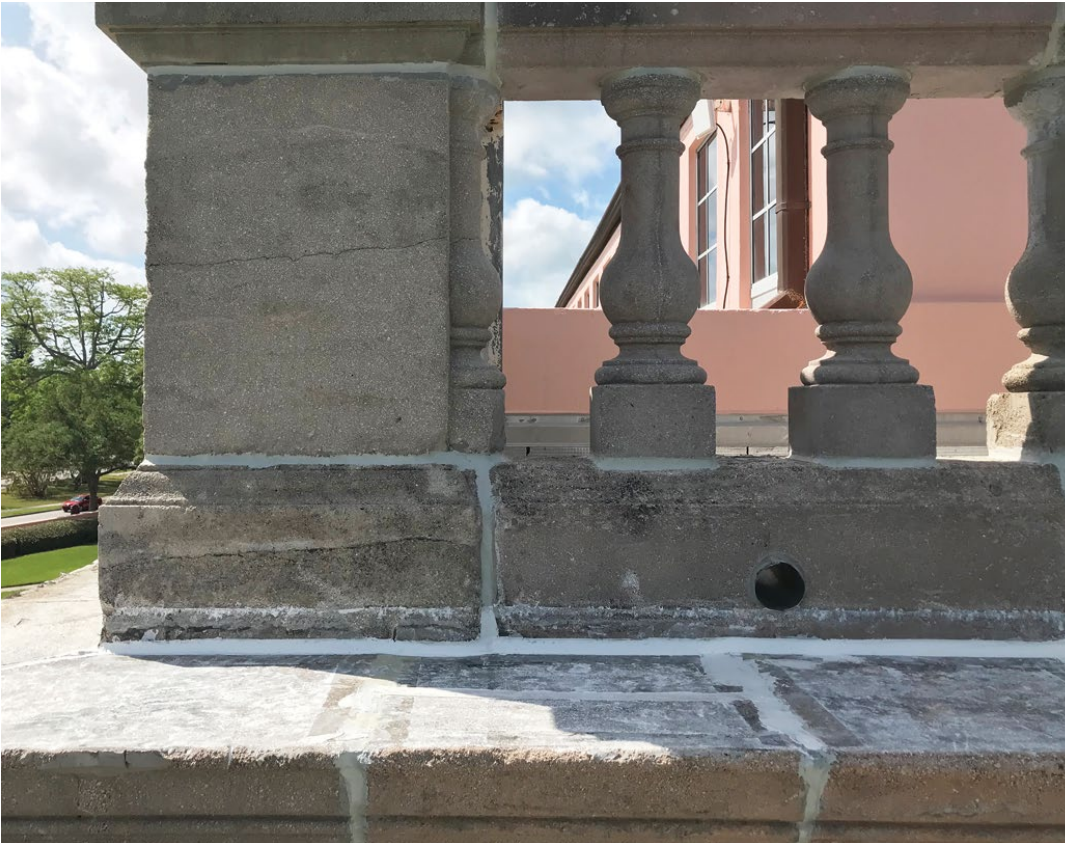
*Figure 17. The balustrade consists of multiple prior campaigns of using cast stone to replace the natural stone. The effective match for the surface texture and color of the original stone allowed individual elements to be incrementally replaced only when they had failed, thus retaining the maximum amount of original material as long as possible. Photo: EverGreene Architectural Arts.*

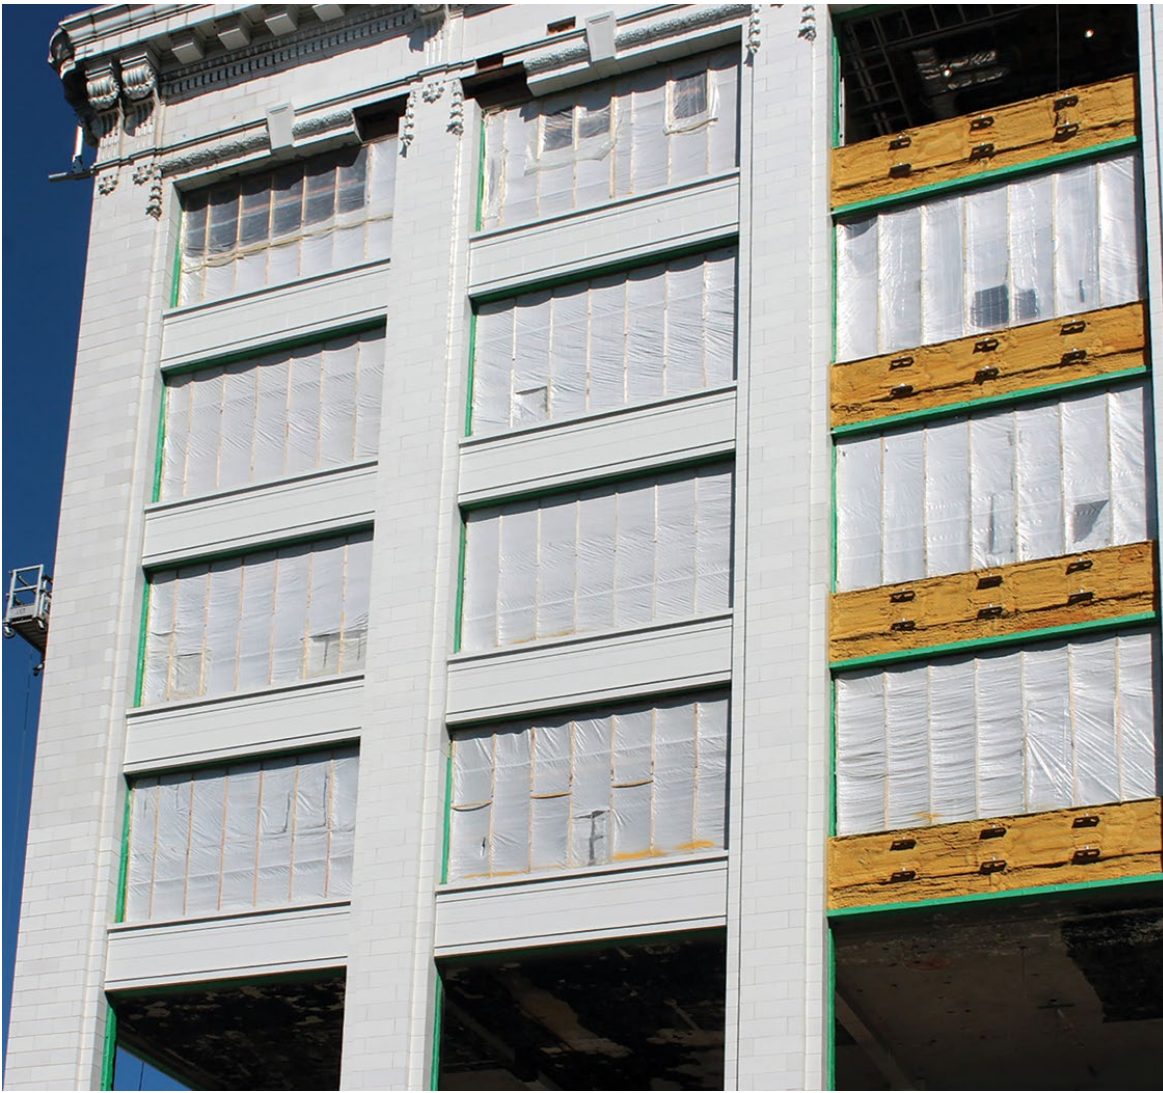
*Figure 18. Missing historic terra cotta spandrel panels on all floor levels were recreated utilizing glass fiber reinforced concrete (GFRC) replacements. New spandrels were fabricated as individual components and attached with metal terra clips between historic terra cotta piers. Photo: Kris Frail, Dewberry.*

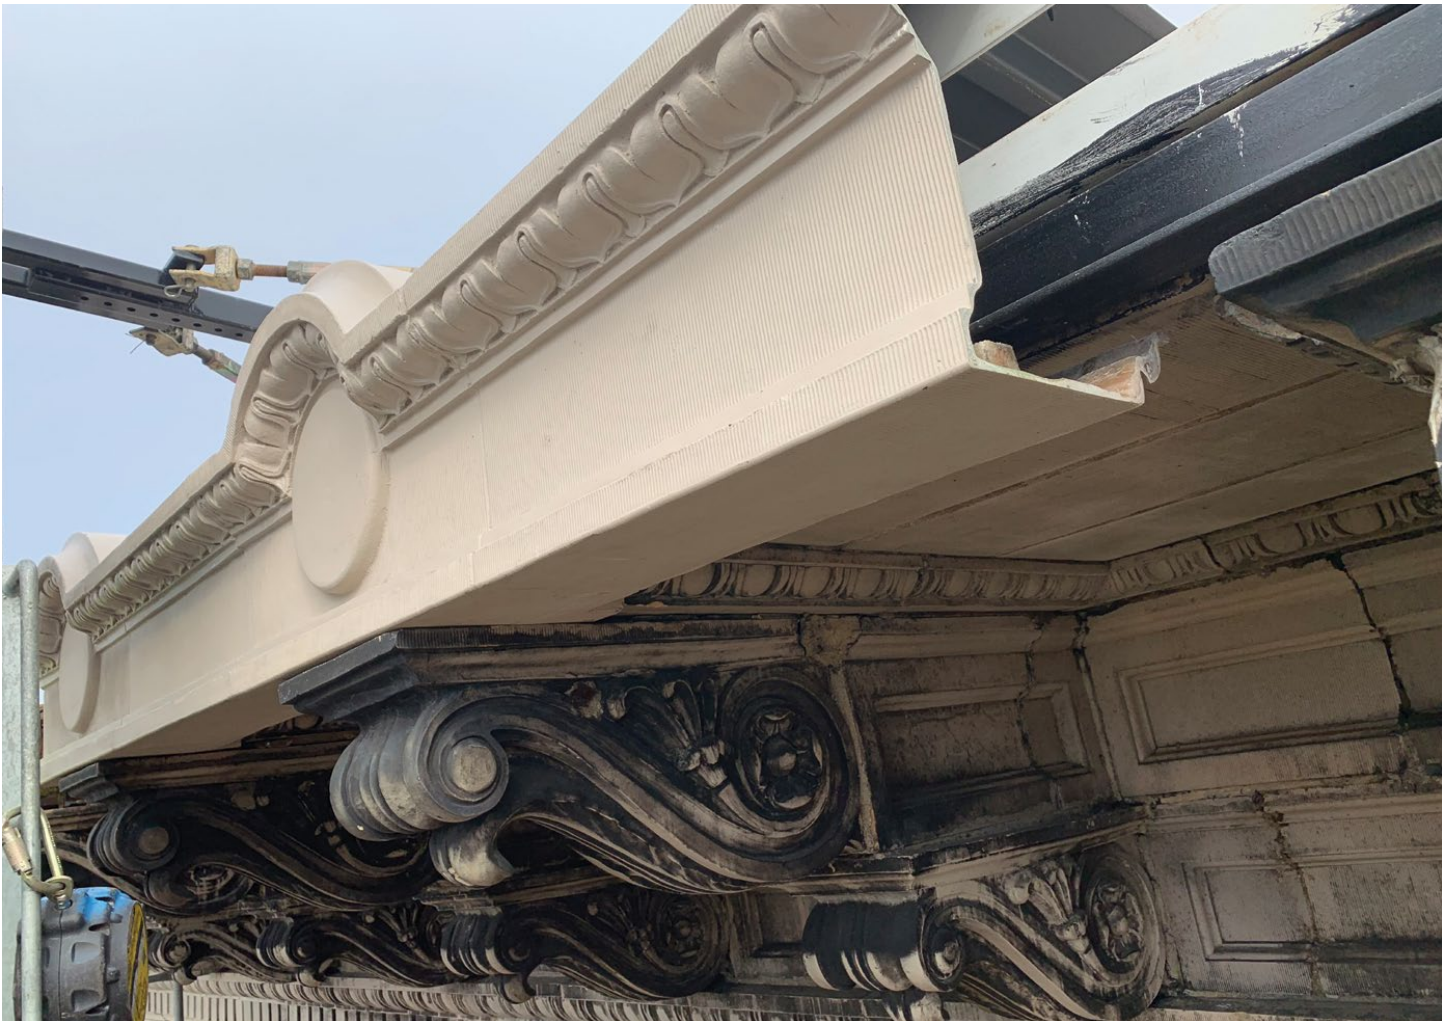
Figure 19. A new, lightweight fiber reinforced polymer is attached to a new metal armature to replicate damaged and missing elements of a terra cotta cornice. Photo: Quinn Evans.

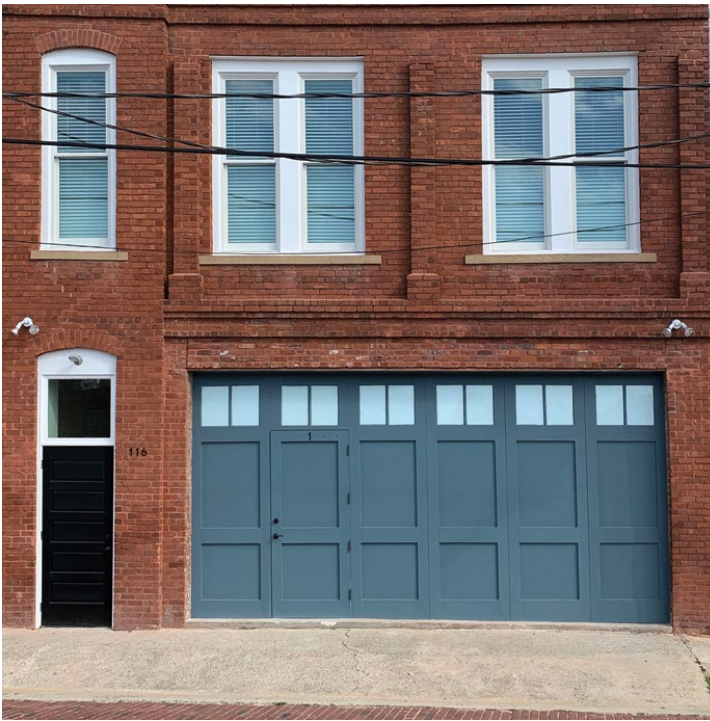
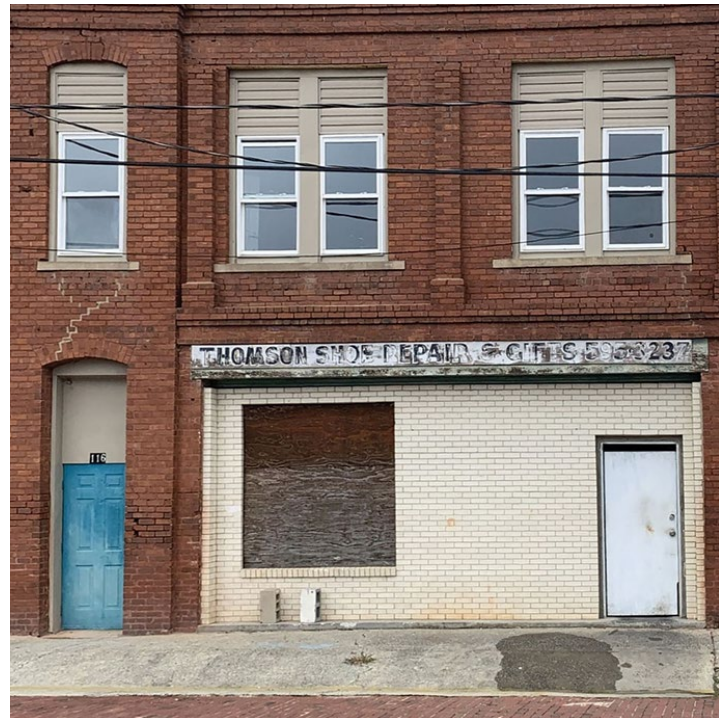
Figure 20. Cement board was used to replace a non-historic infill and mimics the configuration of a typical vehicular door of the period.  
Photos: Historic Augusta.

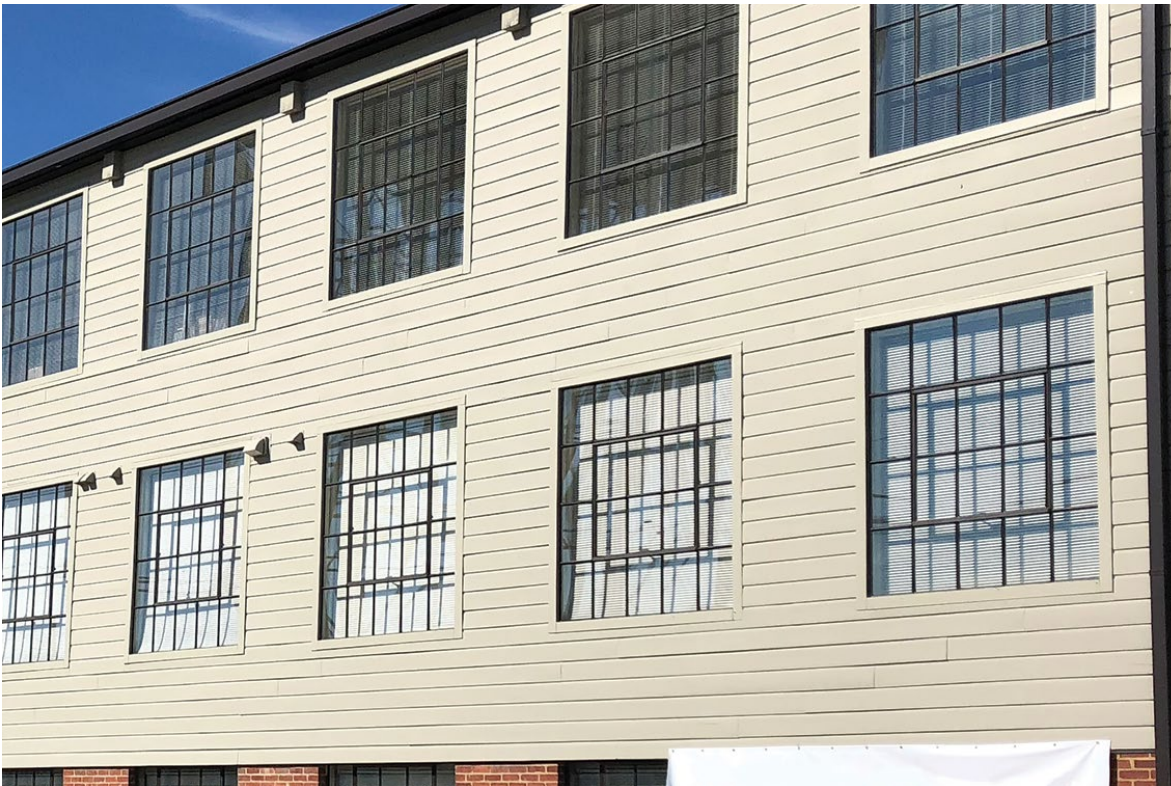
*Figure 21. A mineral polymer composite siding was available in the profile very similar to the historic siding. The replacement siding was used where the original material was almost completely missing beneath a more modern covering. Areas where the original wood was largely intact were replaced with matching wood to sustain more of the material integrity of the building. Photo: Belk Architecture.*

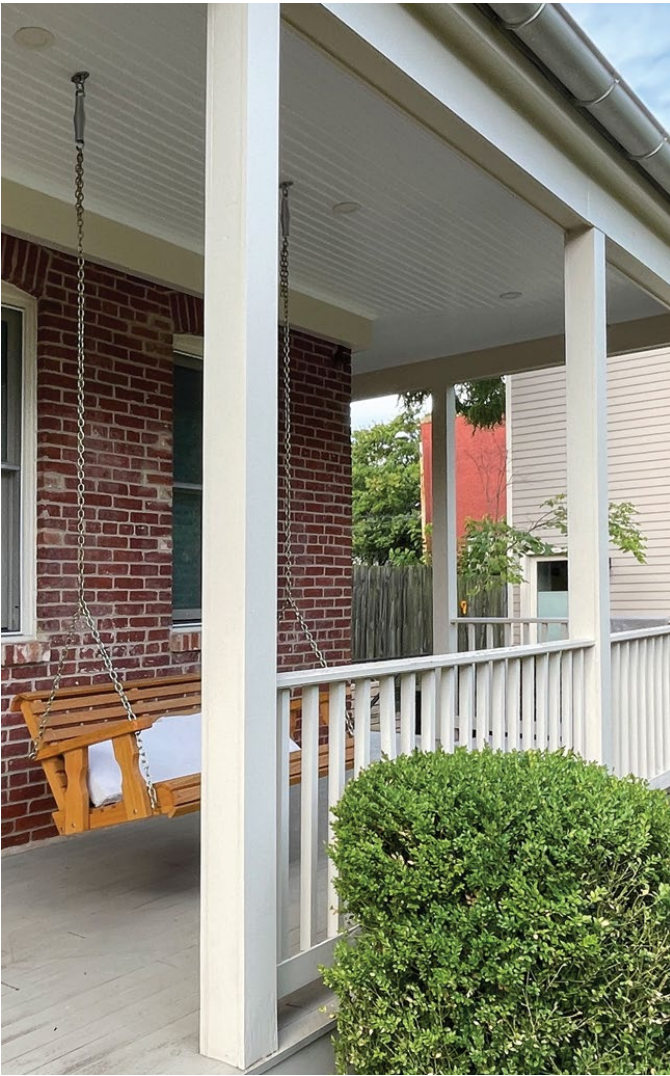
*Figure 22. A porch was reconstructed using posts fabricated on site from a smooth-surface cellulose/polymer composite material. Though the face of the posts are painted, the lack of paint on the bottom at the cut ends is not consistent with manufacturers' recommendations. This treatment will allow moisture to be absorbed, shortening the life of the new replacement feature. Photo: John Sandor, NPS.*

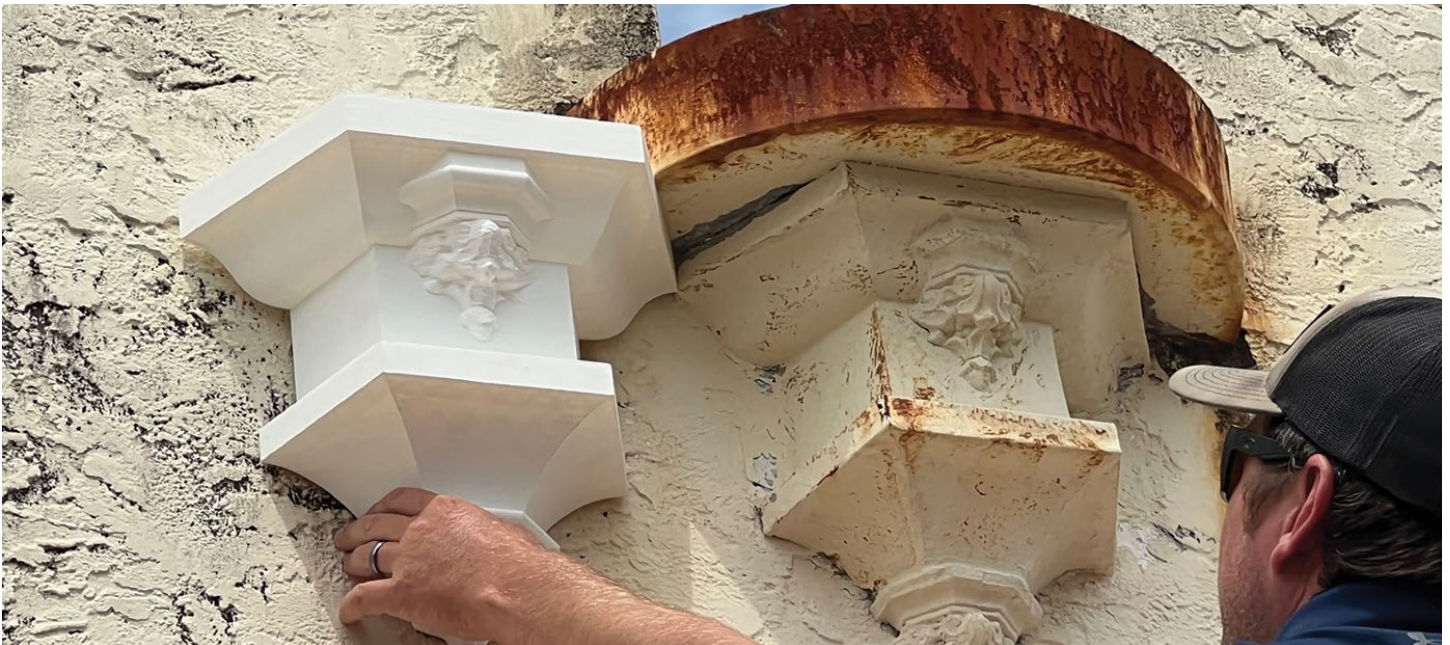
Figure 23. 3-D printing using various polymers is occasionally used to replicate missing metal or wood features. This new application is continually being refined, but the application can be successful when a painted, lightweight feature needs to be replicated. Photo: NPS.
